Zandmotor LiDAR Survey

Field Report

Project: Zandmotor LiDAR Survey

Internal reviewer: R.C. de Zeeuw MSc. Reference: N202010-07_ZandmotorLiDAR

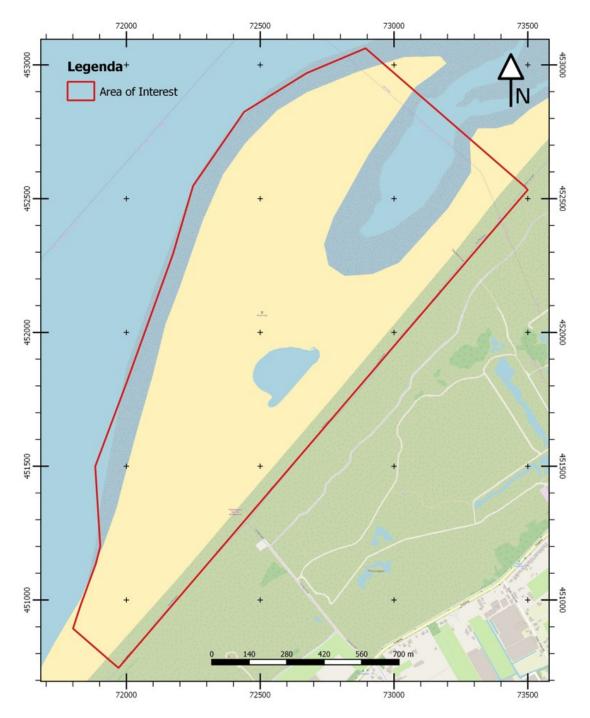
Figure 1.1: Survey area

The area of interest consists of 5 areas perpendicular to the first dune row. For efficient measurements and processing the envelop of the 5 areas is measured (Fig. 1.1).

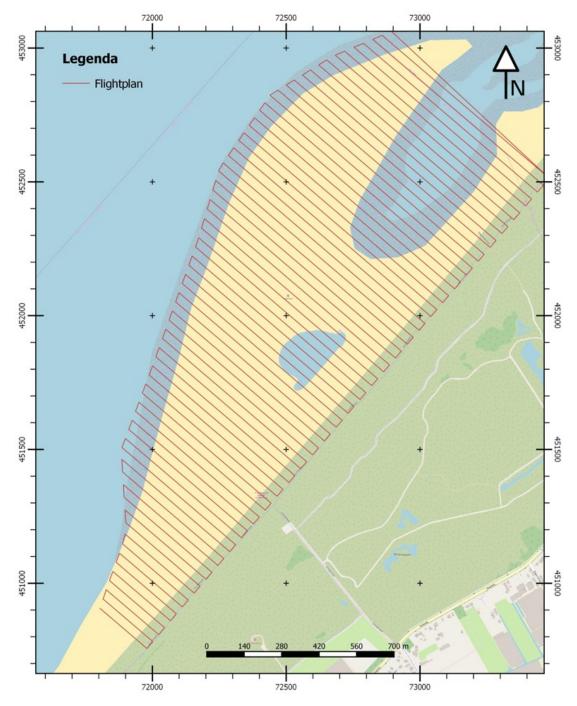
Figure 3.1: Flightplan

The flight plan for the UAV LiDAR flights is presented in Fig. 3.1. Altitude, lines spacing, velocity and overlap are designed to meet the desired deliverables (Tab 3.1).

Parameter	Value:
Altitude	50 m
Velocity	8 m/s
Line spacing	35 m
Lateral overlap images	60 %

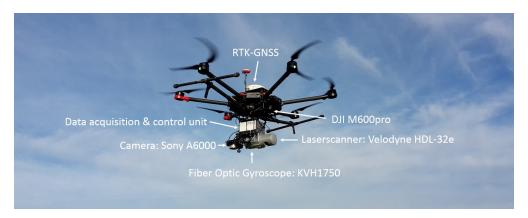
Figure 4.1: Mobie LiDAR system on DJI M600pro. Components annotated.

SHORE uses the AL3-32 mobile LiDAR system by Phoenix LiDAR Systems Inc. The system is usually mounted to a UAV, car or boat. Operation of the systems sensors is independent of the platform it is attached to. Figure 4.1 shows the system on an M600pro, with annotations of the different components.

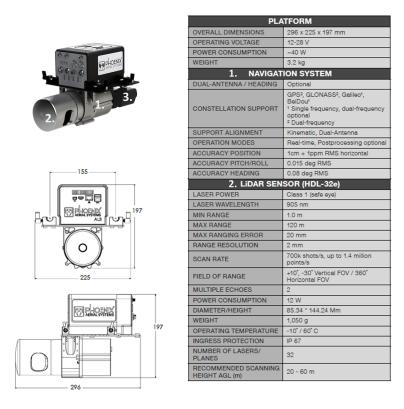
Figure 4.2: Factsheet AL3-32 Mobile LiDAR system.

The system consists of a KVH1750 Fiber Optic Gyro IMU (Fig. 4.2 annotation 1), Velodyne HDL32e laserscanner (Fig. 4.2 annotatio 2), Sony A6000 RGB-camera (Fig. 4.2 annotation 3) and a mini Linux computer which controls and collects instrument data. The IMU forms the heart of the system. Translations and angular offsets between GNSS antenna, camera and laserscanning were measured and preset into the systems software.

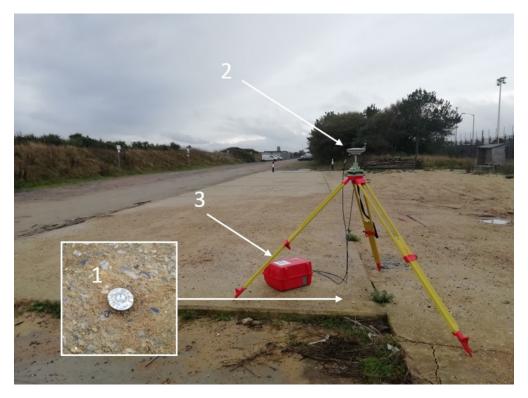
Figure 4.3: Typical base station set-up

SHORE uses a Leica GX1230GG GNSS receiver on a tripod as base station (Fig. 4.3). Manufacturers specifications are presented in Table 4.1.

Instrument:	Brand and type:	Accuracy:
GNSS	Leica GX1230GG	$\pm~2~{ m cm}~+~1~{ m mm/km}$

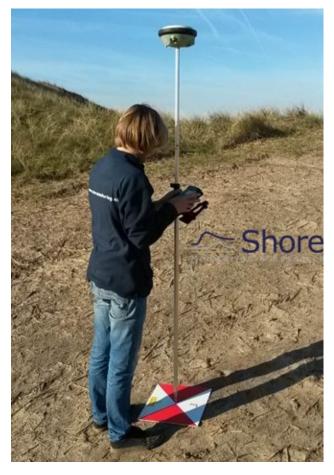
Figure 4.4: Typical rover set-up

SHORE uses several Leica Viva GNSS receivers for GNSS measurements (Fig. 4.3). Manufacturers specifications are presented in Table 4.2.

Instrument:	Brand and type:	Accuracy:
RTK-GNSS	Leica GS10/GS14	$\pm~2~\text{cm}~+~1~\text{mm/km}$

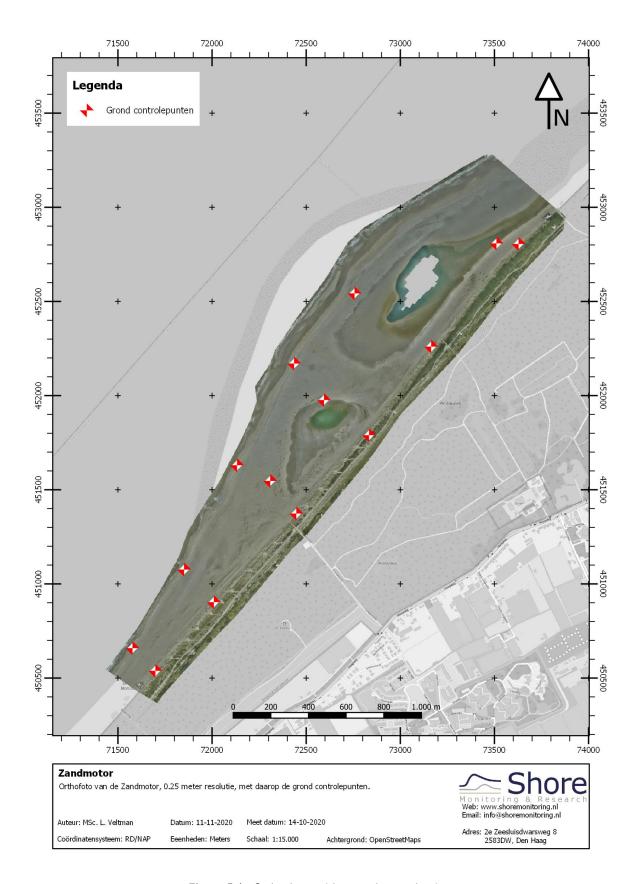
Figure 5.1: Orthophoto with ground control points

- 1. Orthophoto of the AOI, including the location of the gcps. (Fig. 5.1).
- 2. DTM of the AOI, based on only ground point, so excluding vegetation, buildings, objects etc. (Fig. 5.2).

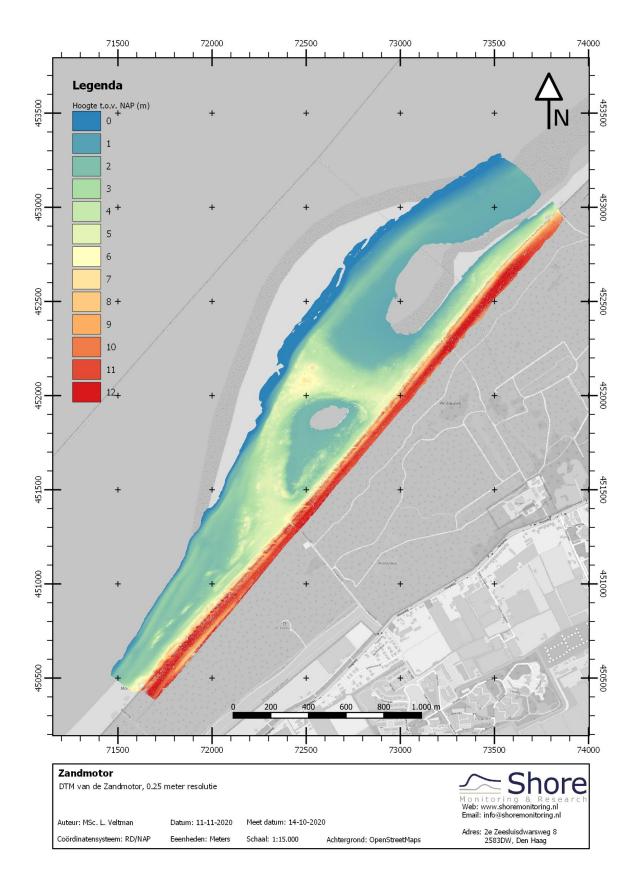
Figure 5.2: Digital Terrain Model (classification of ground points)

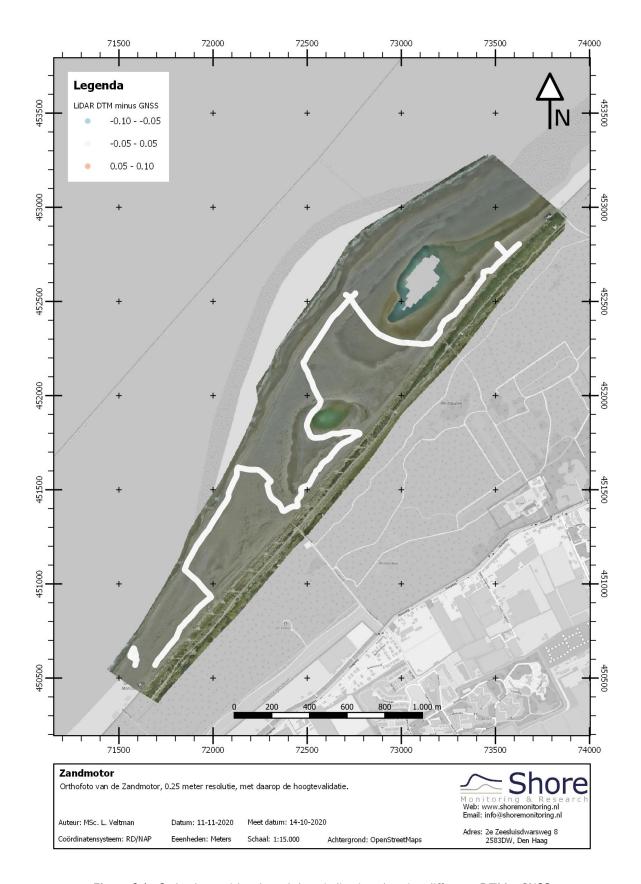
Figure 6.1: Orthophoto with coloured dots, indicating elevation difference DTM - GNSS

- Height validation: elevation difference between DTM and GNSS measurements (Fig. 6.1)
- Planimetric validation: comparison of GNSS and LiDAR measurements of 3D objects (Fig. 6.2).

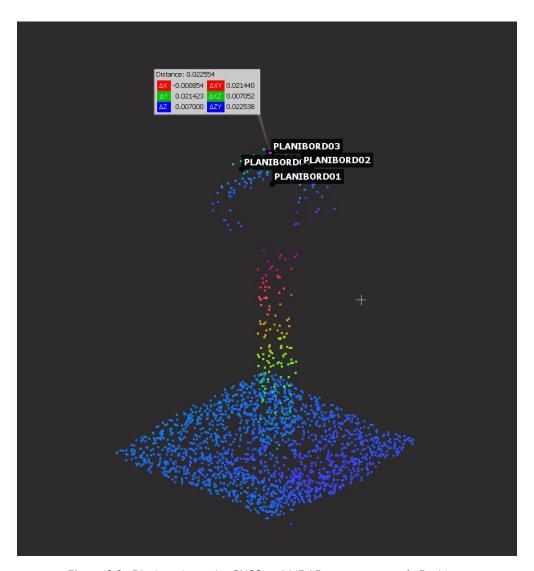
Figure 6.2: Planimetric result: GNSS and LiDAR measurement of 3D object.
